# VEHICLE INSPECTION REPORT

**BF18TFJ**

## Iveco Daily 35-120

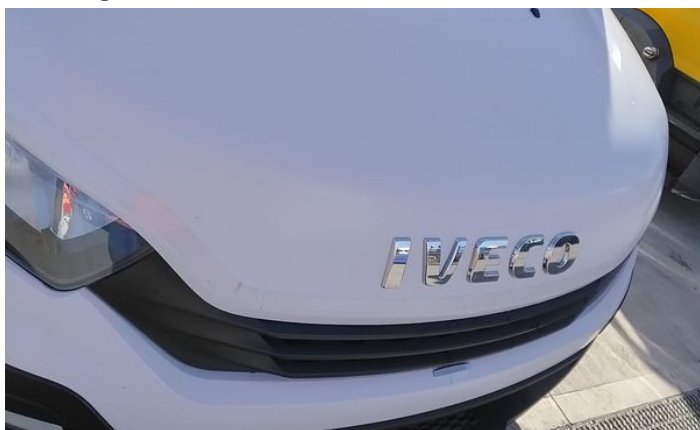
1: Bonnet  
Chipped  
Multiple Chips

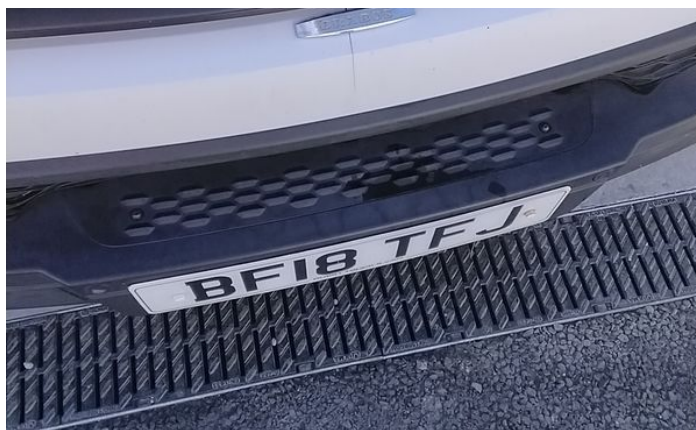
2: Panel Front  
Cracked  
Replace

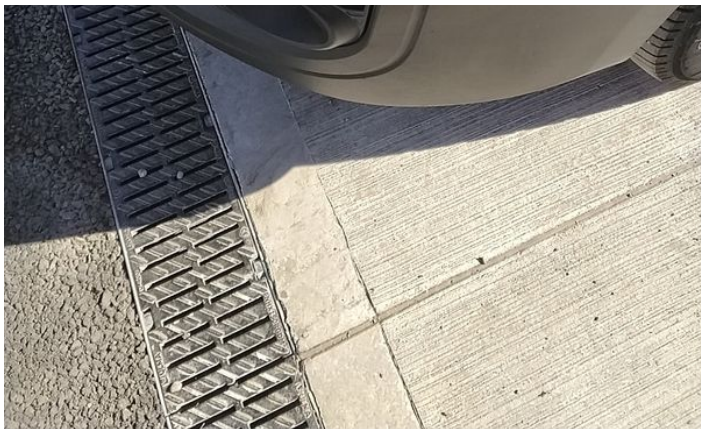
3: Bumper Front Moulding  
Scuffed (Unpainted)  
Over 100mm

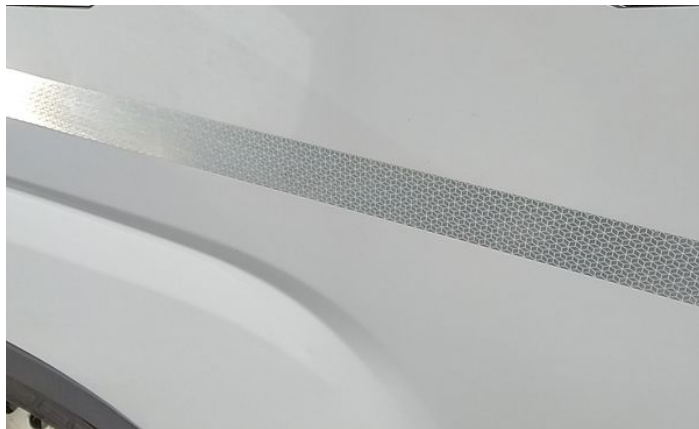
4: Door nsf  
Scratched  
Over 25mm Thru Paint

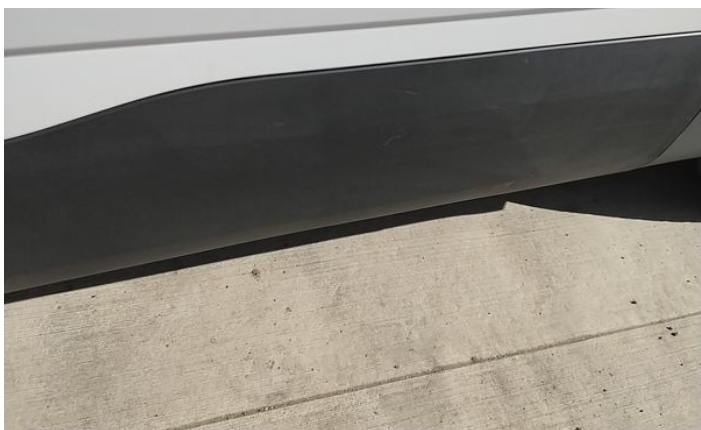
5: Qtr Panel Moulding ns  
Scuffed (Unpainted)  
Over 100mm

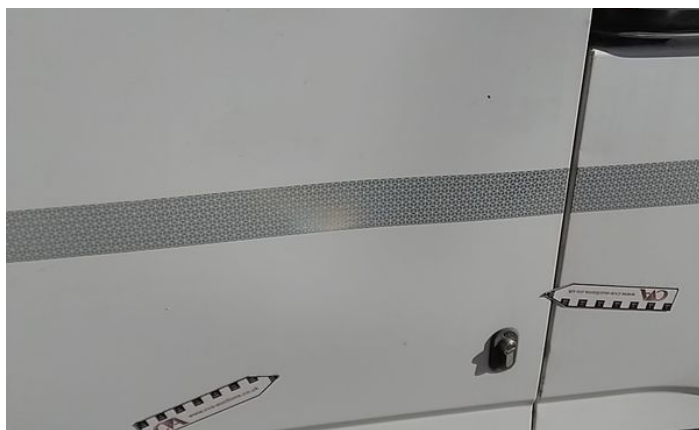
6: Qtr Panel nsr  
Dented  
With Paint Damage

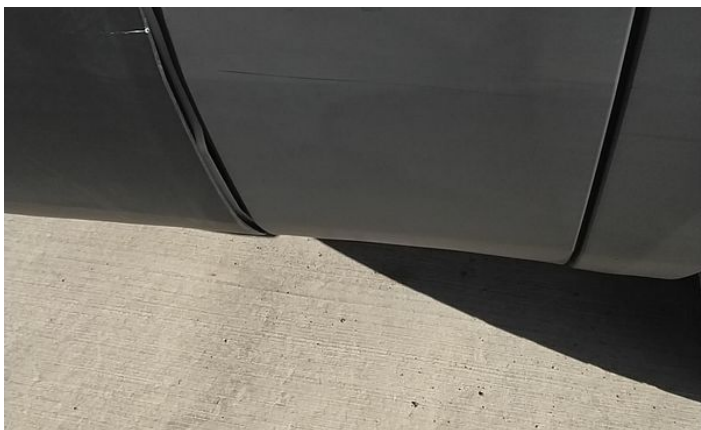
7: Qtr Panel Moulding ns  
Scuffed (Unpainted)  
Over 100mm

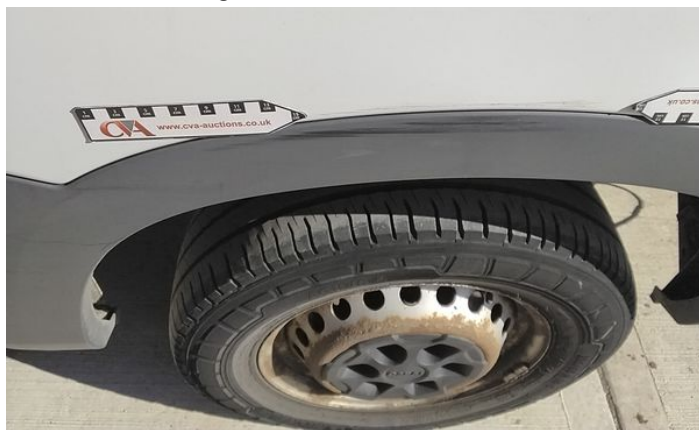
8: Qtr Panel nsr  
Scratched  
Over 25mm Thru Paint

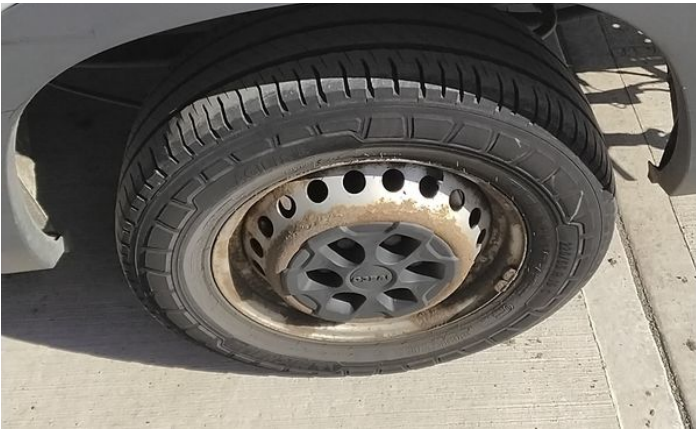
9: Qtr Panel Moulding ns  
Scuffed (Unpainted)  
Over 100mm

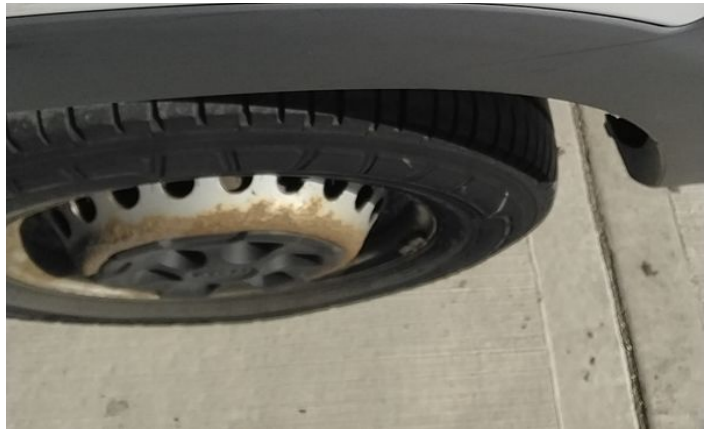
10: Qtr Panel nsr  
Dented  
Over 30mm

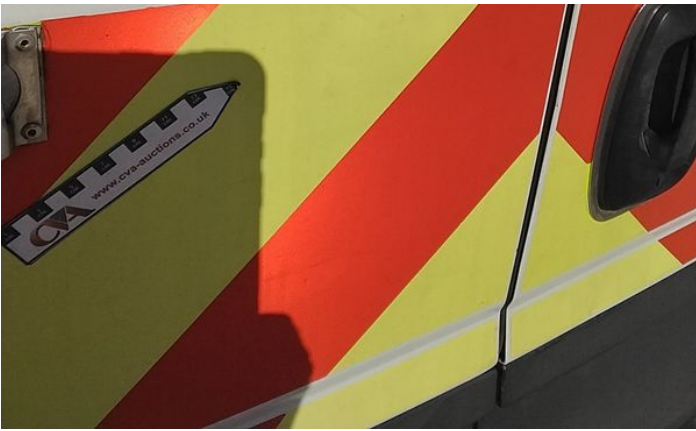
11: Door nsr  
Dented  
Over 30mm

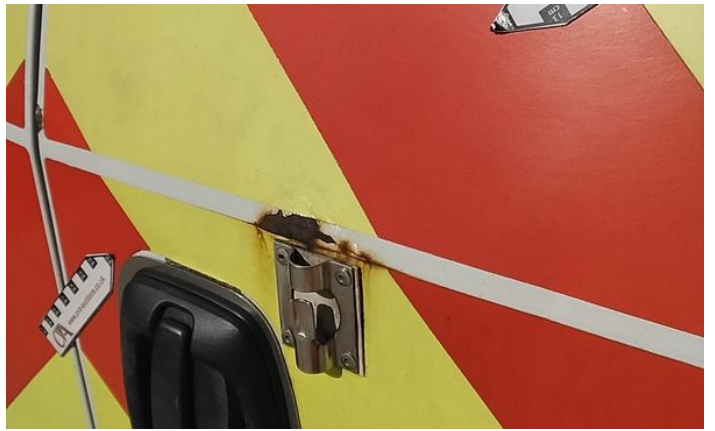
12: Door osr  
Dented  
Over 30mm

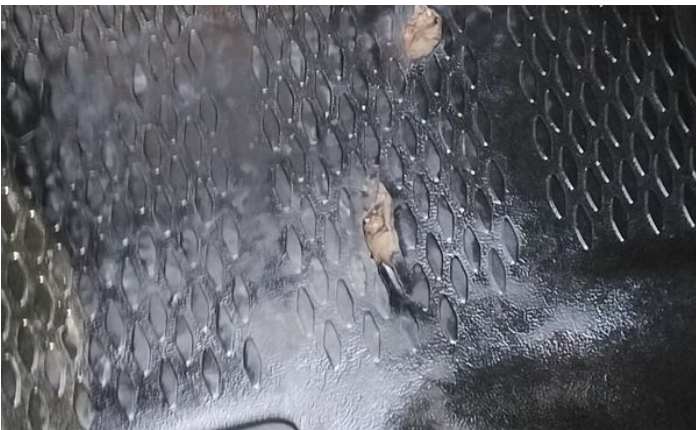
13: Carpets Front  
Holed  
Over 3mm

| <b>Carpet Condition</b> | Poor |

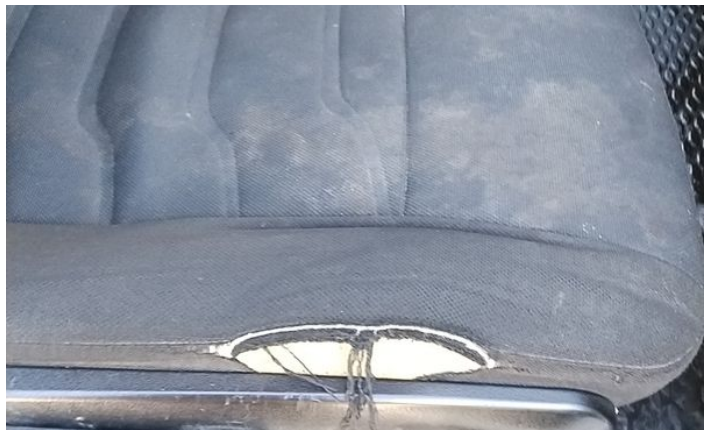
14: Seat Base Cover osf  
Holed  
Over 3mm

| <b>Seat Condition</b> | Poor |

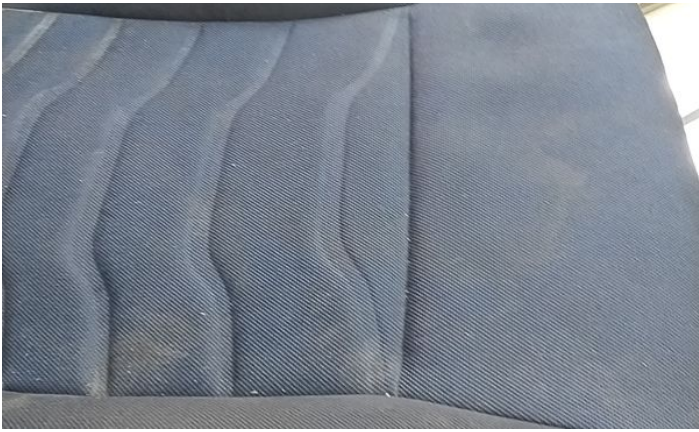
15: Seat Base Cover nsf  
Soiled  
Heavy

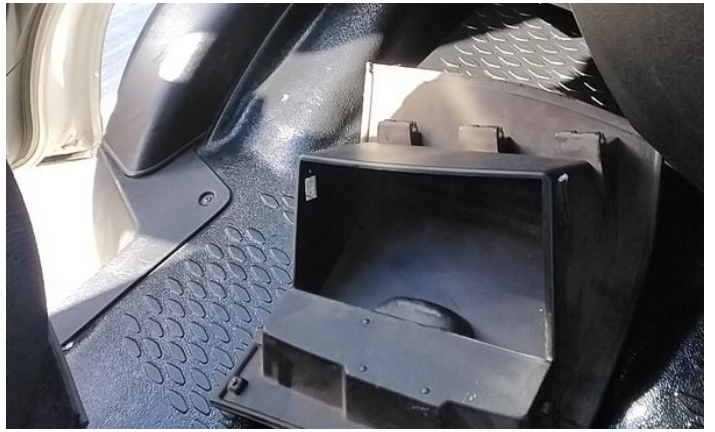
16: Glove Box Lid  
Broken  
Replace
